Maintainer

Issue 3/2004

Critical Maintenance Tasks Requiring an Independent Check

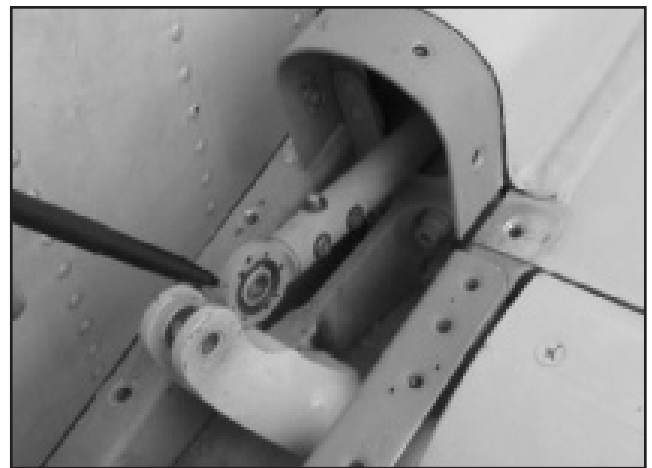
McDonnell Douglas DC-8-71F—Test airplane right elevator control tab pushrod contacting the crank fitting.

The way cargo handling personnel conduct their duties can sometimes have a significant effect on the safety of flight, but in this case, the investigation reported that their performance had not been a factor. What the investigation found was that at some time after the previous takeoff and before the accident take-off roll, the bolt, washer and castellated nut that connected the right elevator control tab crank fitting to the pushrod, migrated out of the fitting, allowing the control tab to disengage from its pushrod and shift to a trailing edge down position. The cotter pin that secured the

castellated nut in place was not found. The aluminium control tab crank fitting and the aft end of the pushrod were intact and exhibited no evidence of internal damage, indicating that the bolt was not in place at impact. By contrast, the aft-end of the left control tab pushrod showed evidence of damage consistent with the bolt having been in place until impact, as it was fractured. The failure of the castellated nut and cotter pin normally affixed to the control tab crank was unlikely and therefore, the bolt must have separated because it was not secured properly nor inspected properly during the airplane's most recent major inspection or subsequent maintenance.

As the airplane accelerated during the take-off roll, the dynamic forces increased and the right elevator control tab crank fitting contacted the disconnected pushrod, restricting that control tab from any trailing edge up movement and positioning it in an extreme trailing edge down deflection. As a result, the elevator surfaces were driven to command an extreme airplane nose-up pitch attitude and the pilots were unable to overcome the effects of the restricted right elevator control tab, despite the large nose-down forces exerted on the control column.

The bolt attaching the right elevator control tab crank fitting to the pushrod had been improperly secured and inspected either during the last "D" type inspection or subsequent maintenance. There were three distinct opportunities to inspect for safety, but everyone failed to recognize the missing cotter pin. The NTSB report recommended, among other things, that the elevator rigging procedures be fully addressed in a separate work card that specifically lists the required inspection items, including verifying the security of elevator control tab attachments after rigging is completed; that all DC-8 work cards related to critical flight controls identify required inspection items as discrete tasks with individual inspection sign-off requirements;

that all air carrier operators provide maintenance personnel with more detailed information regarding the steps or actions that are necessary to satisfactorily accomplish a maintenance task; and that the use of outdated, incomplete or otherwise unsuitable reference materials by maintenance personnel during installation and/or assembly of airplane components can occur and is a very potentially unsafe practice.
